## Planetary Habitat Systems Monitoring On a Mars Analog Mission

### Abstract

The NASA funded HI-SEAS (Hawaii Space Exploration Analog and Simulation) is a planetary surface exploration analog site at ~8500 feet on the Mauna Loa side of the saddle area on the Big Island of Hawaii. This first mission will involve six astronaut-like (in terms of education, experience, and attitude) crew members living in the habitat for 120 days under Mars-exploration conditions. The habitat itself has been outfitted with a variety of real time sensors for water, heat, and energy consumption. This data shows a variety of traits within habitat living conditions that can be utilized for energy and water conservation. This mission started in February and will conclude on August 13th. Data of this type will give a picture of what resources are required for exploration or colonization on other planetary bodies. Future steps for habitat monitoring will be presenting outlining a data fusion model. This model will incorporate fuzzy logic for a centralized intelligent monitoring system.

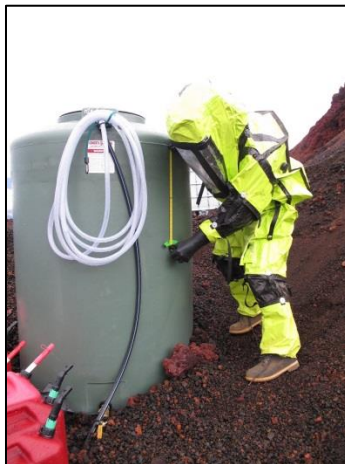
Figure 3: HI-SEAS crew member taking physical measurement of water tank. The yellow simulation suit is a modified bio-hazard suit. Dr. Sian Proctor

The main water tank is a 500 gallon water tank. It uses a ultrasonic level sensor that can detect the water level down to the nearest millimeter. Unfortunately, then water level sensor was subject to calibration issues due to the physical disruption of the sensor caused by refilling the water tank. However, despite the calibration issue, the level sensor was very accurate in determining the change of water depth in the tank from one point to another. Taking a physical measurement once per day allowed one to keep an accurate picture of the amount of water in the tank, while the depth sensor was able to track the rate of water usage in five minute intervals.

Physical measurement of the tank occurred once per day. The crew engineer would exit the habitat in a simulation suit (often a modified bio-hazard suit) and measure the level of water from the top. Using this information the amount of water in the tank is calculated to an accuracy within five liters.

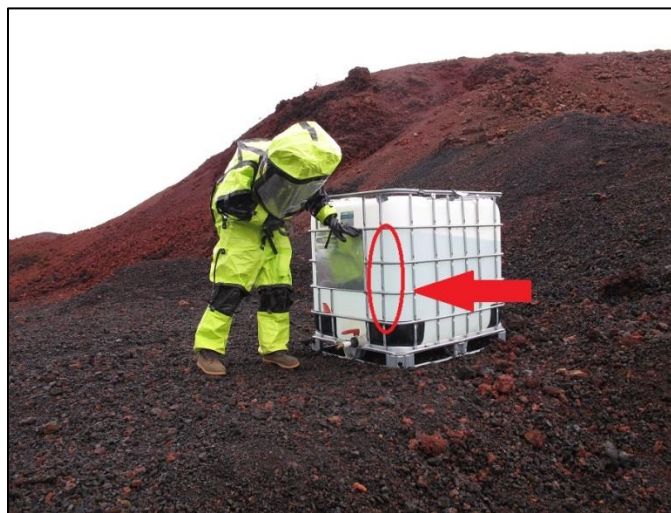
Figure 4: The 250 gallon (946 L) backup tank with graduated measure on the side of the tank highlighted.  
Photo Credit: Dr. Sian Proctor

The backup tank was a 250 gallon (946 L) tank thank had a ruled gauge on the side of it. If the main tank fell in short supply the crew engineer would have to transfer water from the backup tank by manually placing a water pump in-between the two tanks. Dominantly, this tank was dormant for the majority of the mission.

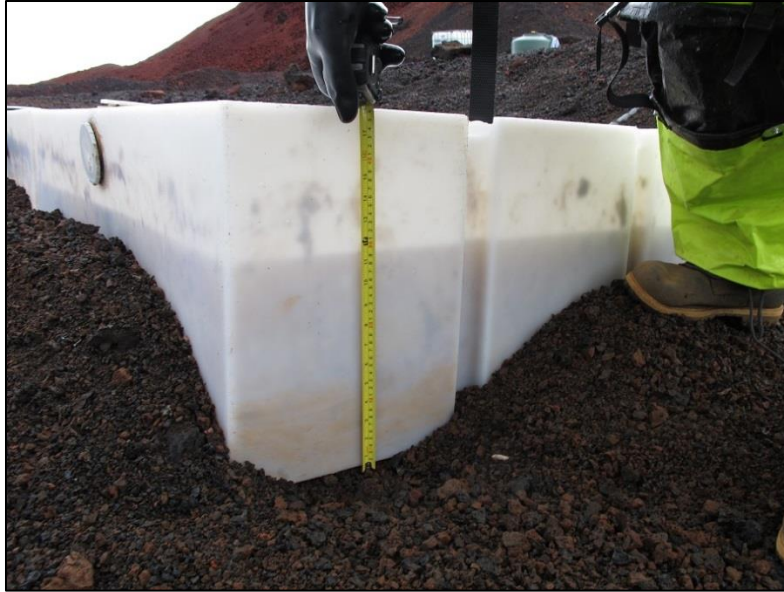
Figure 5 The 500 gallon (1893 L) septic tank being manually measured for its current capacity. Photo Credit: Dr. Sian Proctor

The septic tank consists two 250 gallon (946 L) tanks. At the current setup of the habitat plumbing, all water minus water from the washing machine flows into the septic tank. The tank did not have a meter and required manual measurements for data collection. The translucent material would show the water level inside the septic tank. By measuring the height of the waterline, the volume of sewage inside the tank could be calculated.

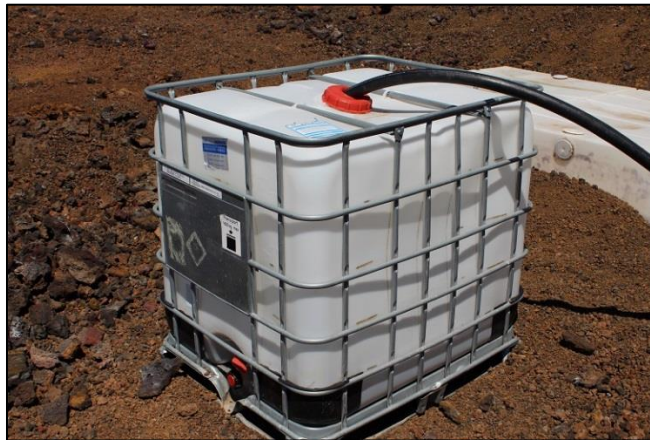
Figure 6 The 250 gallon grey water tank. Measurements were manual using graded markings on side of the tank. Photo Credit: Dr. Sian Proctor

The 250 gallon (946 L) grey water tank was filled entirely by the habitat washing machine. Since the septic tank was drained every six days, so was the grey water tank. The graph in Figure X shows the level of the septic tank over time. The crew used an average of XX gallons per week. The crew was restricted to one wash per week with the washing schedule spread out by allowing only one wash per day.

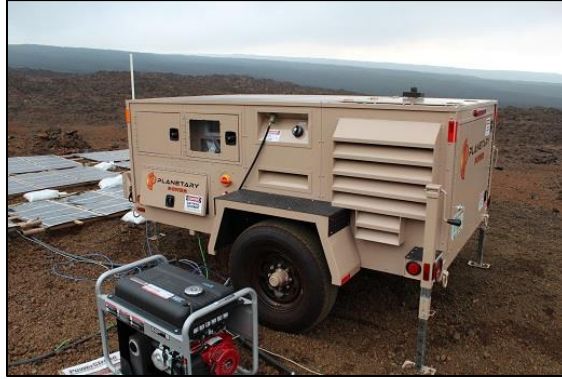
Figure 7: Planetary Power generator seen with the Honda backup generator

The HyGen system is a trailer with photovoltaic (PV) solar panels. It utilizes a three cylinder diesel engine that is turbocharged to ensure power output is sufficient for an altitude of up to 9000 feet. [2] The generator will produce 90 Hz power output that is converted to alternating current (AC) and direct current (DC) from 350VAC to 395VDC. The direct current is passed through an inverter and converted to 120/208 VAC. The excess power is stored in Lithium Ion (Li-Ion) batteries with a capacity of 7 kWh. The solar panels seen in Image X can produce up to 3kW that is used to charge the batteries. The HyGen is serviced by refueling the diesel supply and monitoring the oil levels of the diesel engine. [2]

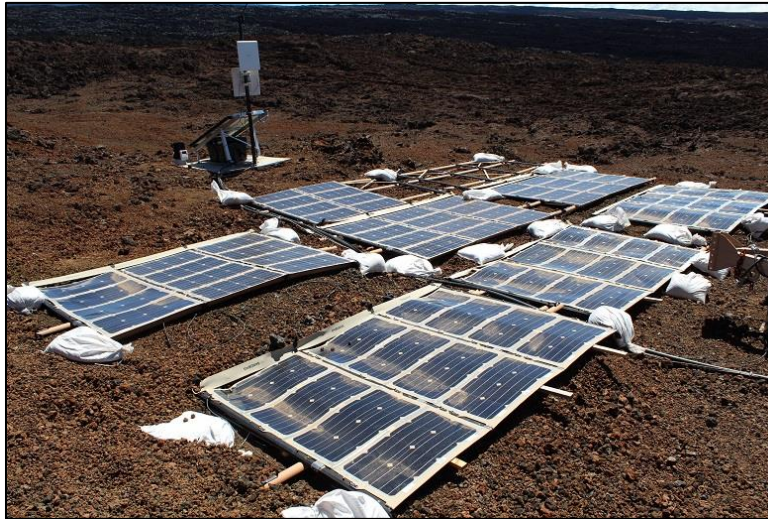
Figure 8 Solar panels provided potential voltage power to the hybrid generator. Photo Credit: Simon Engler

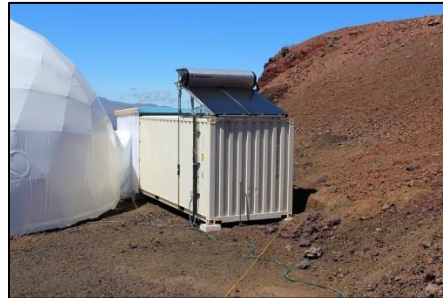
Figure 9: The 150 gallon solar water heater. Photo Credit: Simon Engler

Hot water for the habitat was provided by a solar water heater. This solar water heater would heat water contained in a 150 gallon insulated tank. Hot water was available to the crew well after sundown. This was a passive system and required no maintenance from the crew Engineer. The daily cycle of temperature of the solar heater can be seen in the temperature telemetry of hot and cold water tanks.

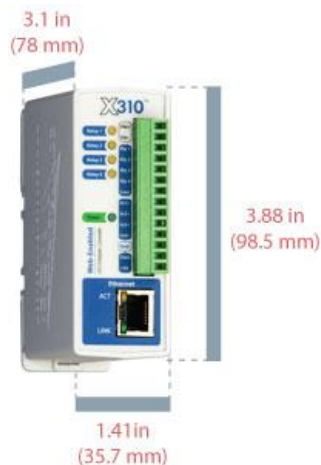
Figure 10: The ControlByWeb X310 Telemetry router

The habitat system was outfitted with a sensor telemetry routing system. A ControlByWeb X-310 web interface was utilized to control and collect sensor information and distribute to a remote location. The X-319 is a Ethernet I/O module with four digital inputs that allows for support of up to four temperature and humidity sensors. It also has the ability to control remote relays which allowed the crew to control in air intake/outtake fan. This sensor was interfaced by the web and could be controlled externally to the environment. It has a built in web-server which allows for direct connection to the module and allows for eternal control in this manner. Using this technology, the habitat was enabled to monitor and log power supply using a customization through a web based control page. Software allowed for graphing of telemetry and also the extraction of the data into CVS files allowed for statistical analysis.

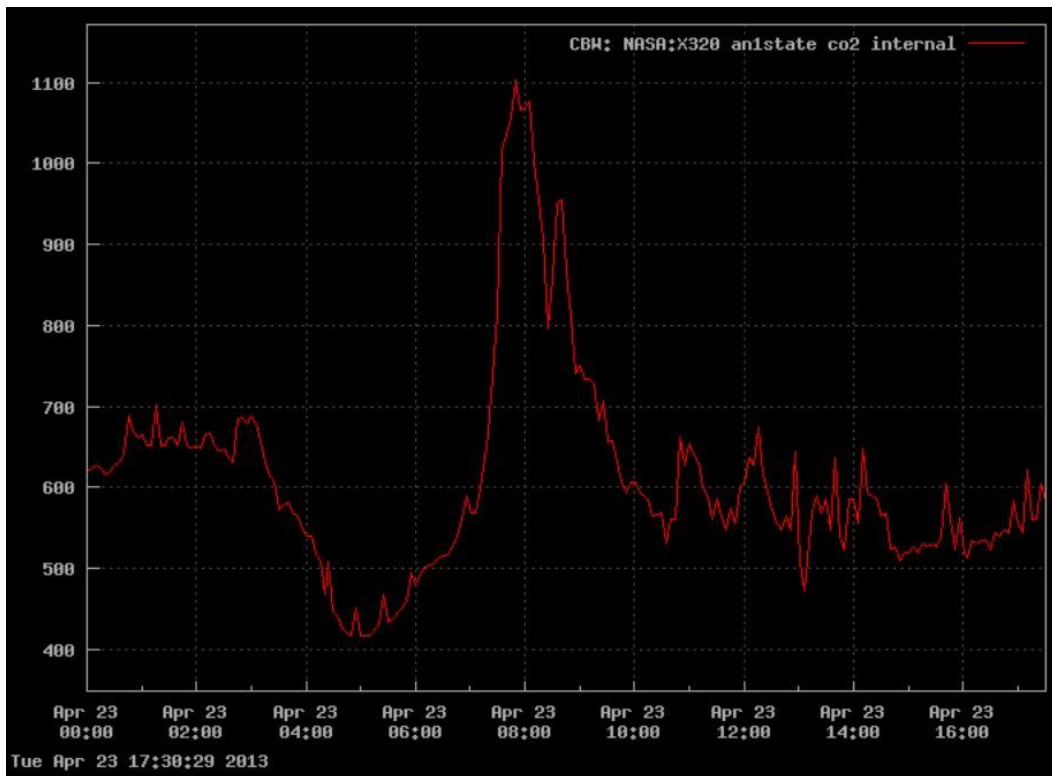
Figure 12: CO2 sensor cycle in the habitat. It is possible to identify crew activities by the changes in the CO2 levels.

From the CO2 sensors, the daily cycle and activities of the crew can be determined. When the crew went to sleep they would shut their bedroom doors. This would trap most of the CO2 in their rooms, which would be vented to the outside. As a result, the CO2 levels in the habitat would drop considerably. One can see times that crew members used the restrooms during the evenings by the slight temporary increase in CO2 levels. Once the crew woke up for the day, some members of the crew would engage in their morning workouts. The crew activity would drive the CO2 levels in the habitat up to its highest point of the day. Afterwards, the CO2 levels would drop again once breakfast and the morning meeting had concluded. The crew would then go about their daily business causing fluctuations in the CO2 levels until they went to bed for the evening.

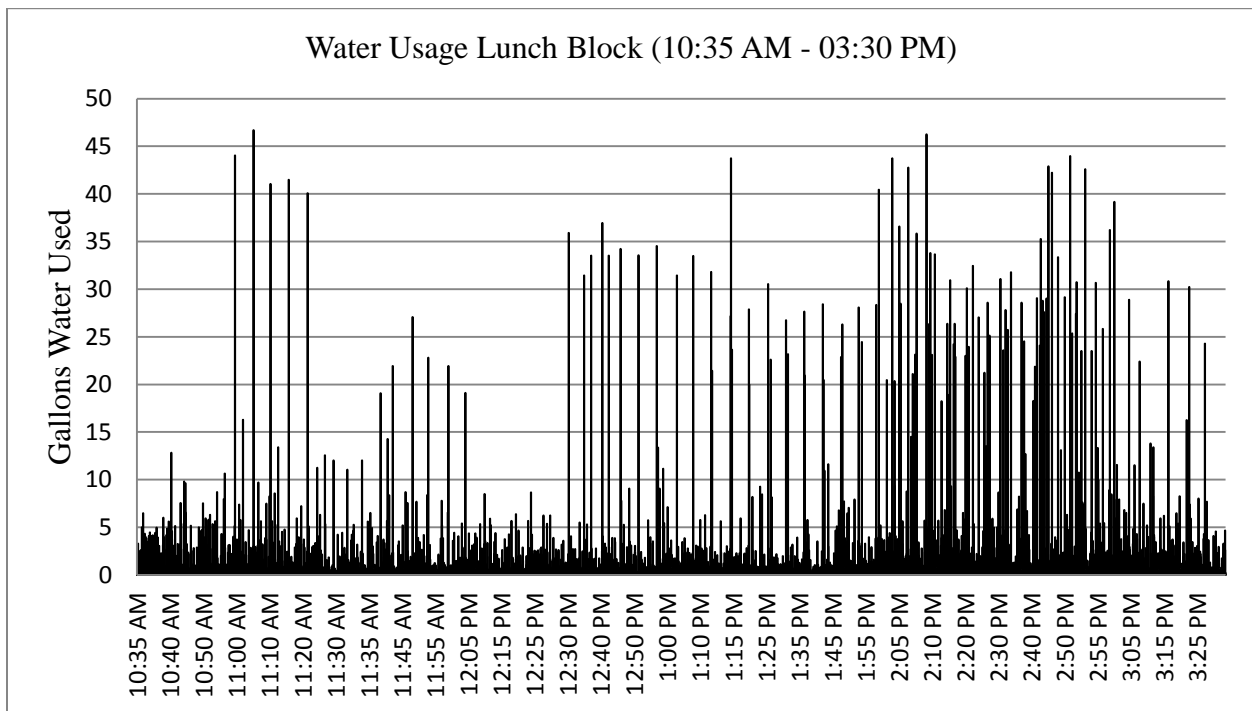
Figure 19: Water consumption over the lunch block.

Water consumption during the lunch block sees a dense increase of water usage starting between the hours 1:00 PM – 1:45 PM, this coincides with preparing lunch meals. Water usage is then significantly higher between the hours of 1:55 PM -3:25 PM. This time range is consistent with the times crew would be washing dishes from lunch, and would be incorporated to water usage from the laundry machine. Sometimes crew members would start washing dishes at different times during lunch throughout the mission. One can see that the dominant water usage in this block is clearly from washing dishes.

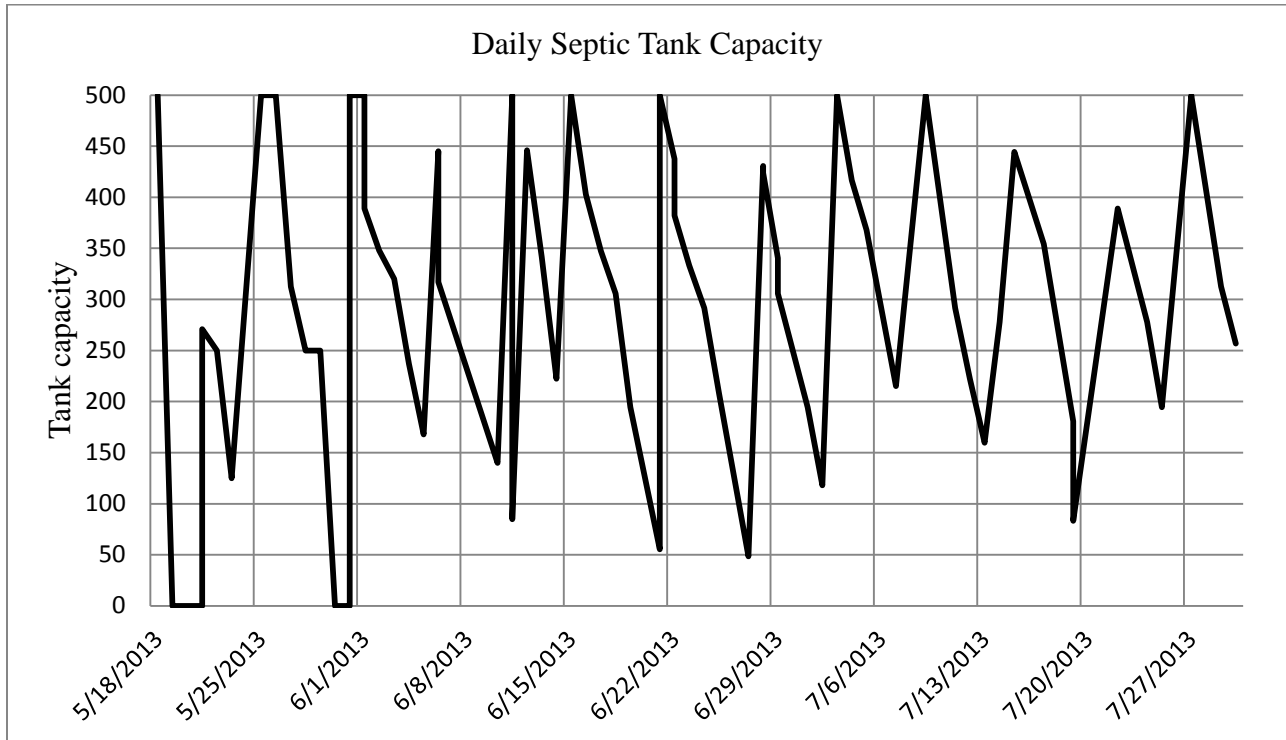
Figure 22: Daily septic tank level over course of the mission

The 500 gallon septic tank would reach its capacity every 6 days. For this reason it was emptied by sea septic removal service. If the septic tank reached its capacity, then the crew would be required to go on water restrictions. This did not occur after the first four weeks of the mission once the crew settled into a regular routine. The septic tank was taking all the water from the habitat, minus water from the washing machine. This was not the ideal setup but was done out of necessity.

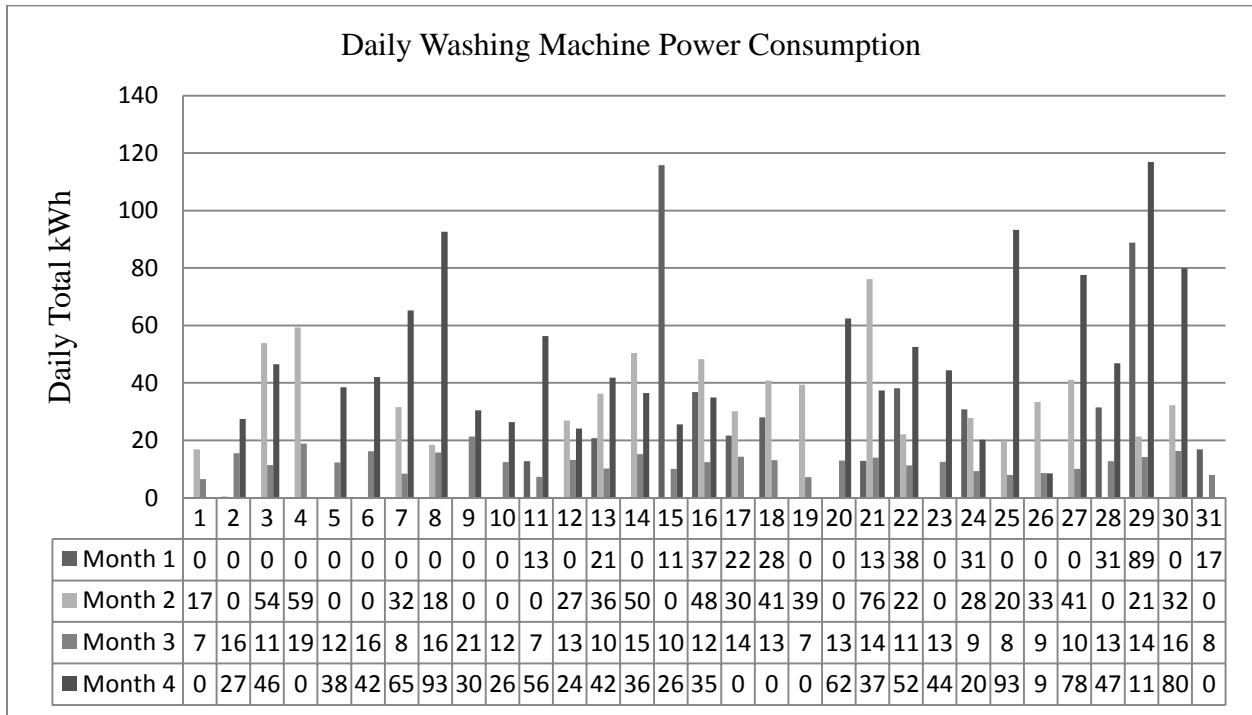
Figure 25: Daily washing machine power consumption over four month mission

The washing machine purchased for this mission turned out to be a highly inefficient machine. On a large load, it would consume a very large 62 gallons per wash. This was a significant issue at the beginning of the mission, as it caused a couple days of water shortages due to the unexpected amount of water used. To

combat this extreme water consumption rate, crew was restricted to setting the washing machine on the low setting, which used a more reasonable 16 gallons per load. The crew was also assigned a specific day to do their laundry allowing to spread the crew washes over six days, with an extra day for washing dish clothes and other communal items. There was a higher usage of the washing machine towards the end of the fourth month due to some textile studies, and prepping the habitat for the end of the mission. Overall, the washing machine used a grand total of 2790 kWh, with a monthly average of 697 kWh at standard deviation of 279 kWh.

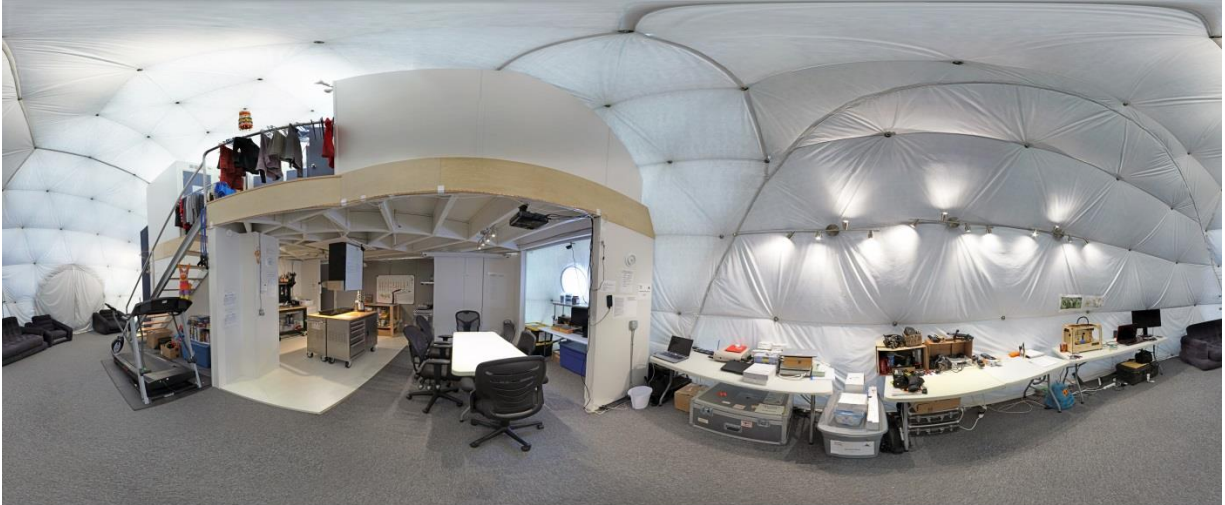
Figure 36: A photograph and thermal images of the habitat at day and night.

A comparison of daytime and nighttime spherical ( $360^\circ \times 180^\circ$ ) thermal panoramas encompassing the central dome area of the hab, as well as a visible-light panorama for context, are presented in Figure 35:

The daytime panorama was acquired in the afternoon of 7/10. Weather conditions as reported by the habitat's weather stations were clear skies, light and variable winds, and an ambient temperature of 23 °C.

Observed temperatures range from a high of ~34 °C along ceiling of the dome to a low of ~18 °C. There is a strong vertical temperature gradient present; temperatures increase with height from ~21 °C underneath crewmembers' work desks to over 34 °C at the dome ceiling. The highest temperatures are concentrated in the southern quadrant of the dome and above crewmembers' staterooms.

The nighttime panorama, acquired on 6/21, provides a thorough overview of the temperature distribution in the hab during the evening. Weather conditions at the time were clear skies, calm winds, and an ambient outdoor temperature of ~10 °C. The mean temperature of the PVC cover is ~15 °C. Heat loss along the side and bottom seams, and especially along the airlock door is clearly visible. A modest temperature gradient of ~2 °C is noted along the walls of the dome, with the ceiling being warmer, likely due to rising air currents. Heat produced by various electrical appliances, particularly the space heater, electric tea kettle, and the dishwasher is clearly visible. Heat appears to be trapped below the floors of the second-floor structure, and appears to be particularly concentrated below room #1 for reasons that are not entirely clear.

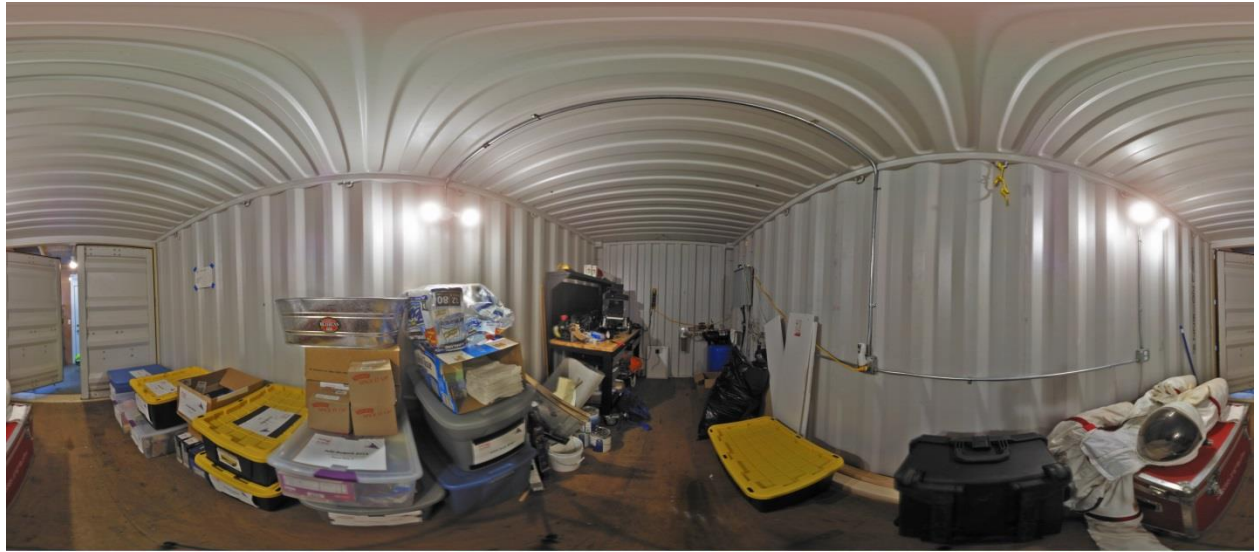
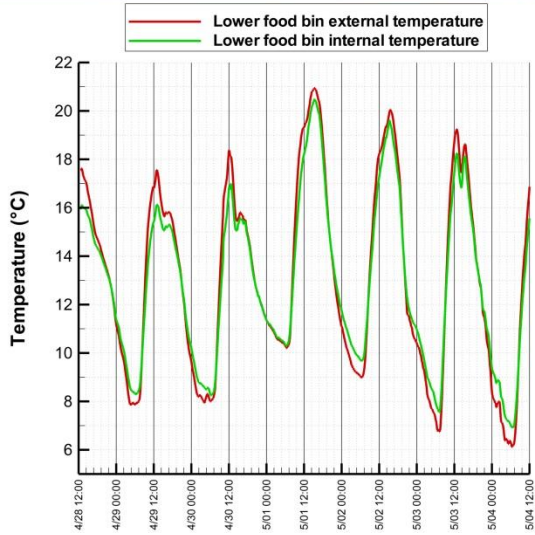
Figure 40: Thermal properties of sea container used for food storage.

The main food storage area in the HI-SEAS habitat is along the east wall of the steel shipping container that is also used as a workshop and robot garage. Because of concerns of possible food spoilage due to perceived high temperatures within the container, particularly in the afternoons of sunny days, OMWT-TEMP15 wireless temperature sensors and thermal imaging were used to evaluate the diurnal temperature distributions within the container and assess their impact on food storage. The results, including a sample late afternoon spherical ( $360^\circ \times 180^\circ$ ) thermal panorama, a visible-light panorama for context, and data from temperature sensors are presented in Figure 39.

The thermal panorama of the storage container shown in Figure 41 was acquired on July 8 at 16:00. Atmospheric conditions at the time of imaging were clear skies and winds averaging 16 mph from the north. Observed temperatures range from a high of 34 °C along the west wall to a low of 17 °C in the southeast ceiling quadrant. The high temperatures along the west wall are explained by direct incident sunlight in the late afternoon, and the low temperatures in the southeast part of the ceiling are due to shade provided by the solar panels and the hot water tank installed in that area (Fig. 9). In general, the ceiling area remains fairly cool despite direct sunlight due to a layer of insulation present there. The second-coolest locations are near the container floor and the east wall, which is adjacent to a cinder cone (Fig. 9) and remains mostly shaded throughout the day. Temperatures increase with height, and both horizontal and vertical thermal gradients are present across the food storage boxes. Temperatures of the lowermost food boxes have range from 19 to 22 °C.

The overall conclusions from this assessment were as follows: (i) Temperatures within the lower bins are acceptable for food storage; they had a mean of ~13 °C during the observation period and briefly reached a maximum of ~20 °C on the hottest day of the week. (ii) Food storage acceptability decreases with increasing height above the container floor. It was recommended that foods with any degree of perishability (processed cheese, cured meats, etc.) are only stored in the lower bin, or, at most, near the wall-facing side of the upper bin. (iii) Only very temperature-stable foods should be stored in the cardboard boxes above the bins. (iv) Insulation and/or a reflective layer added to the west wall of the container would significantly reduce daytime temperature spikes.

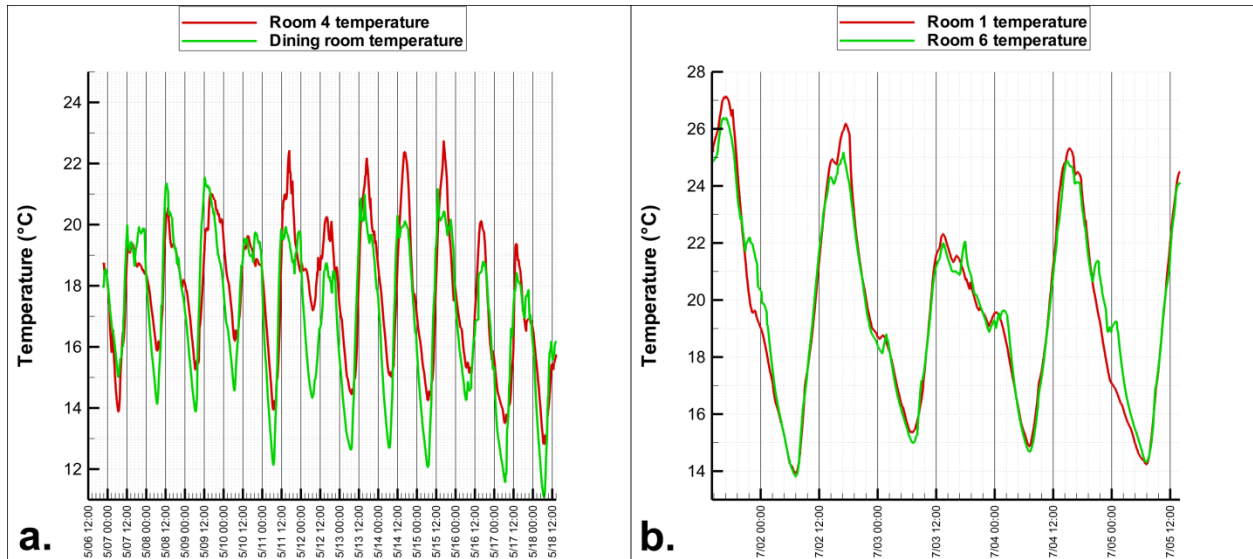
Figure 45: Temperatures in habitat staterooms

Figure 43a presents data collected in May from a wireless temperature sensor in stateroom #4, and, for comparison, one in the kitchen/dining room area. Prior to May 10, it was standard practice to leave one of the portable 1500-watt Lasko heaters running overnight on the ground floor. The results of turning off the heater beginning the night of May 10 – May 11 are clearly visible in Figure 44a. The dining room temperature decreased ~2.5 °C from the baseline mean; however, the effect on bedroom temperatures was significantly less pronounced, with a decrease of ~1-1.5 C from the baseline mean, suggesting that the heating benefits were fairly marginal and did not outweigh the electrical power costs of running the heater overnight.

The effects of installing single-paned acrylic windows on May 15 are also apparent, with daytime highs in both the dining area and the bedrooms being  $\sim 1\text{-}2$  °C lower. Based on this data, it was recommended that the window in the lab be removed and replaced with the PVC cover that was there previously, and the window in the dining room area be double-paned.
